Hawaiian Volcanoes During 1951

GEOLOGICAL SURVEY BULLETIN 996-D

By GORDON A. MACDONALD and CHESTER K. WENTWORTH

*A report of the Hawaiian
Volcano Observatory*

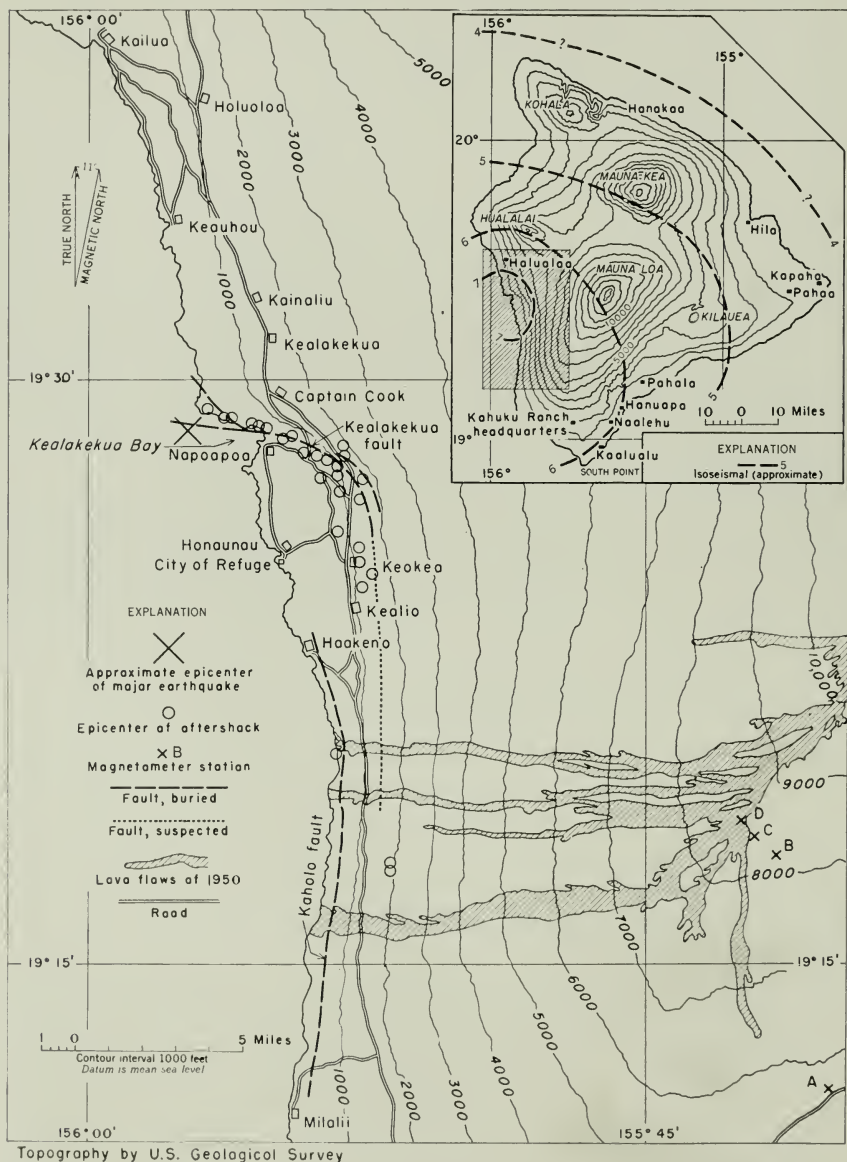
FIGURE 41.—Map of the central Kona district showing the location of places mentioned in the text, and the approximate locations of the epicenters of the major earthquake of August 21, 1951, and the aftershocks for which reasonably good locations were obtained. The inset map of the island of Hawaii shows the location of the area (shaded) covered by the other map, and the approximate position of the isoseismal lines for the major earthquake.

The loose-stone walls characteristic of the Kona area were extensively damaged by the earthquake. The greatest destruction was in the area between Keauhou, 3.5 miles north from Kealahou, and Pahoe, 3 miles south from Hooke, (fig. 41). However, isolated instances of wall derangement were observed as far north as Honokahau, 16 miles north of the epicentral area, and Naalehu, 36 miles southeast. The distribution of damage to walls is shown graphically in figure 43. Many miles of wall required rebuilding. As the cost of contract rebuilding is about a dollar a yard, the total monetary loss from the destruction of walls is very appreciable.

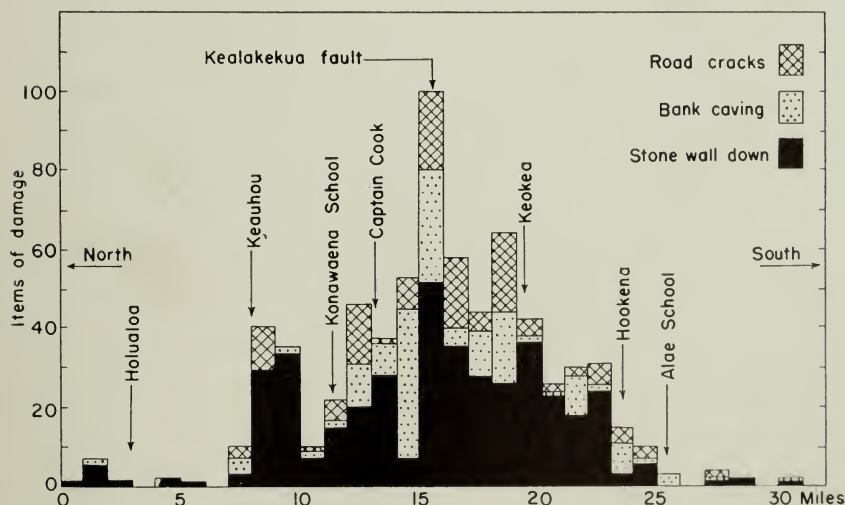
A large part of the damage to road cuts did not result from land slides. Most of it was caused by loose or semiloose material rolling down the slope and fraying the banks. Few of the highway cuts exceeded 5 feet in height, or were dressed back to any approximation of an equilibrium slope. The earthquake of August 21 greatly exceeded in size any previous quake in the affected area since the road cuts were made, and dislodged much of the loose material and allowed it to roll onto the road.

The distribution of abundance of rock slides in road cuts is shown in figure 43, in which it is represented by the portion of the columns labeled "bank caving." Like the other damage shown in the graph,

FIGURE 43.—Diagram showing the frequency distribution of three of the principal types of earthquake damage along the main highway. The arrows indicate the position on the highway of some villages and other features. Note the centering of damage near the Kealahou fault.

it was greatest in the immediate vicinity of the Kealakekua fault, inland and a little south of Kealakekua Bay.

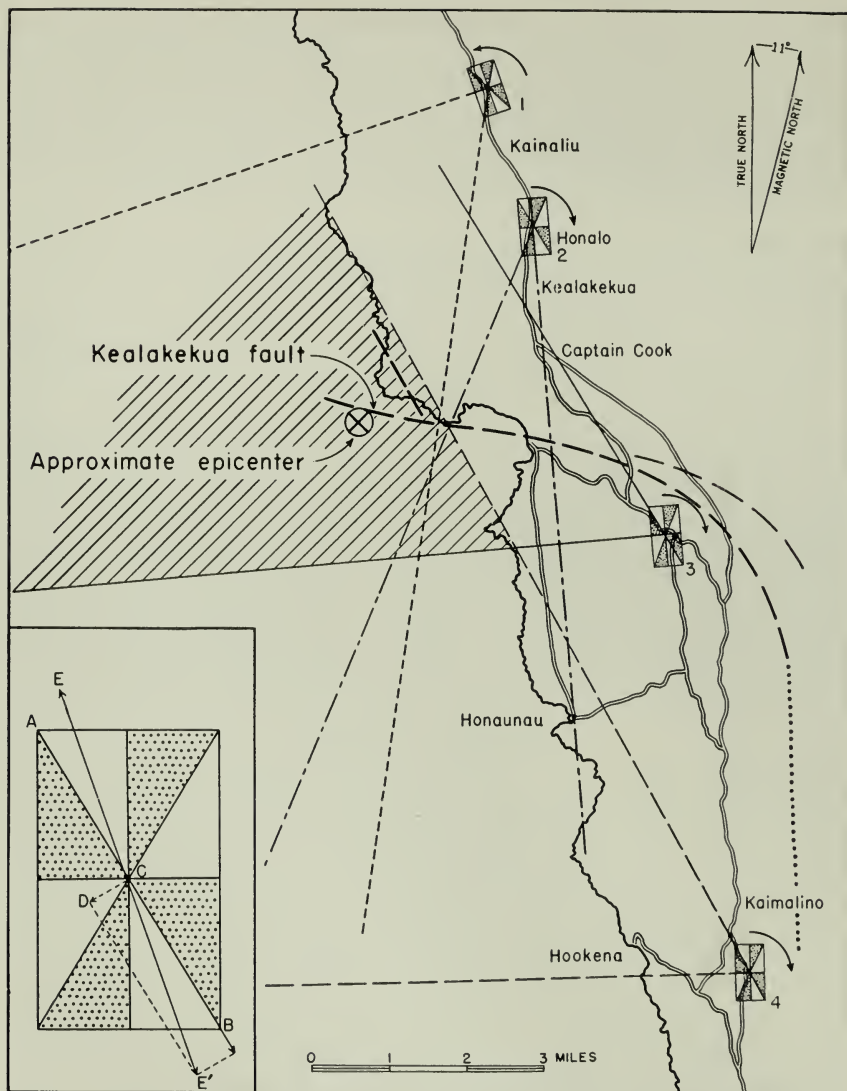
FIGURE 48.—Map of the central Kona area, showing the prevalent direction of rotation of monuments in cemeteries. The cemeteries are indicated on the map by numbers as follows: (1) Daifukuji, Honalo; (2) Hongwanji Mission, Kealakekua; (3) Hongwanji Mission, Kei; (4) Kalabiki Japanese. At each cemetery the arrow indicates the prevalent direction of rotation. The boundaries of the octants containing the direction toward the epicenter are prolonged. The cross-hatched area west of Captain Cook is that in which three or more of the octants overlap. The inset in the lower left is a diagram (after Imamura, 1937) of a horizontal cross section of a rectangular column, indicating the manner in which horizontal earthquake motion ($E-E'$) brings about rotation of the column.

In figure 48 is shown the prevalent direction of rotation of monuments in four cemeteries. Four other cemeteries were omitted either because no monuments were rotated or because the number was too small to yield a reliable statistical result. At each of the four cemeteries plotted the boundaries of the octants containing the direction toward the epicenter are prolonged. In an area west of the shoreline, from 2 miles south to 2 miles north of the approximate trace of the Kealahou fault, three or more of the four significant octants overlap, and it is within this area of overlap that the epicenter should be situated.

The prevalent direction of rotation of columns in cemeteries indicates a location of the epicenter within the shaded offshore area in figure 48. This area contains the seaward extension of the Kealakekua fault.
